Leisure Trail UK & KTM EFI Service Tips

Service recommendations for EFI models

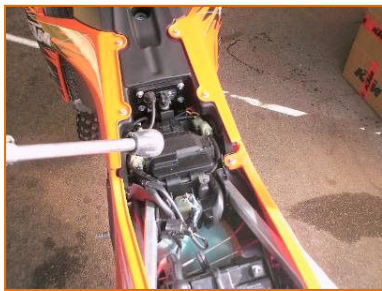
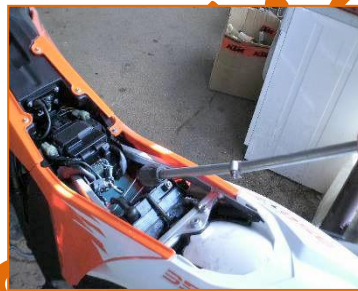
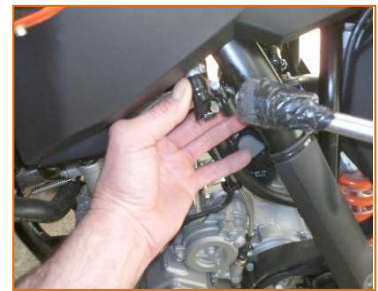
Checks of faulty EFI components often reveal damage caused by stone impacts or contamination caused by the introduction of dirt and water during cleaning and maintenance. The use of pressure cleaners in particular often leads to the ingress of water and dirt into cable and plug-in connections and EFI components. **Do not direct the pressure lance at any electrical or EFI components, do not use a pressure under the fuel tank or seat see below.**

WRONG

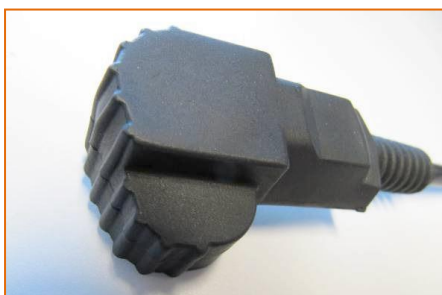
To prevent this, KTM developed **protection cap 771 11 014 050 (£3.66)**, which will be installed as standard beginning with model year 2012, but which can be retrofitted in all 2011 models

To properly retrofit this component, special tool art number 000 29 014 008 and art number 000 29 014 009 are needed to release the plug-in contacts of the cable from the TPS connector housing to be able to introduce the cable into the protection cap. This task is best performed by a KTM dealer with specialised tools.

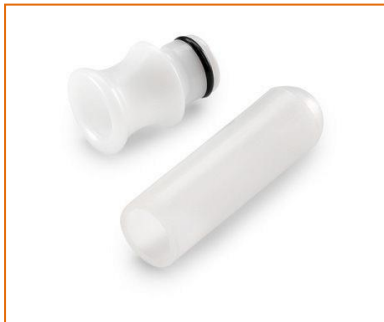
An important measure when cleaning the motorcycle when the tank is removed is to use the **wash cap set (£8.17)**

Before disconnecting the fuel line coupling, it is important that the coupling and its immediate vicinity is cleaned thoroughly and that the wash caps not be mounted beforehand. This ensures that dirt cannot enter the coupling to the injector valve

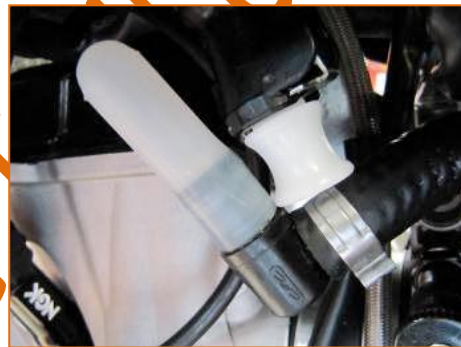
Blanks fitted

The wash caps prevent dirt from entering the parts of the disconnected fuel line coupling when the tank is set down. When the tank is set down, the coupling with the mounted wash cap should not touch the ground. Instead, the fuel hose should be held up on one side.

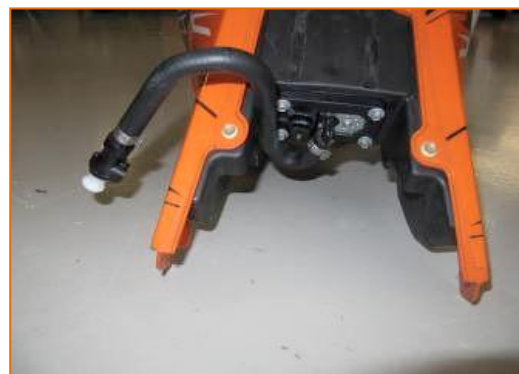
RIGHT

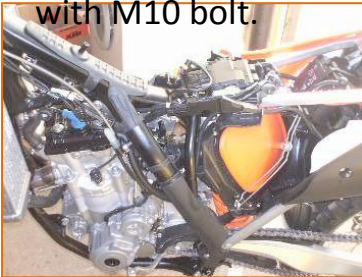
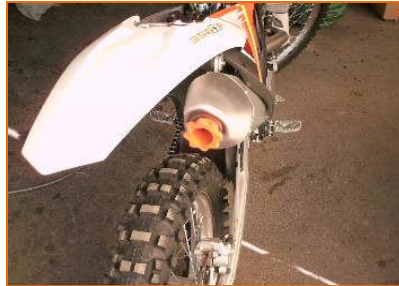
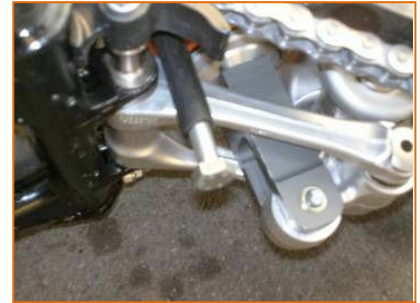
Other important steps to take when cleaning an offroad motorcycle are closing off the intake opening to the filter box; inserting a cloth in the opening under the wash cover to prevent water from entering the throttle valve body-be sure to remove the cloth again after washing; and closing off the main silencer **(Silencer Bung £4.95, Air Filter Cover Plate £8.25)** and the engine breather

with M10 bolt.

After washing, it is important to start the vehicle and let the engine warm up so that the plug-in connections can dry, thus preventing corrosion. This is also mentioned in the Owners Manual

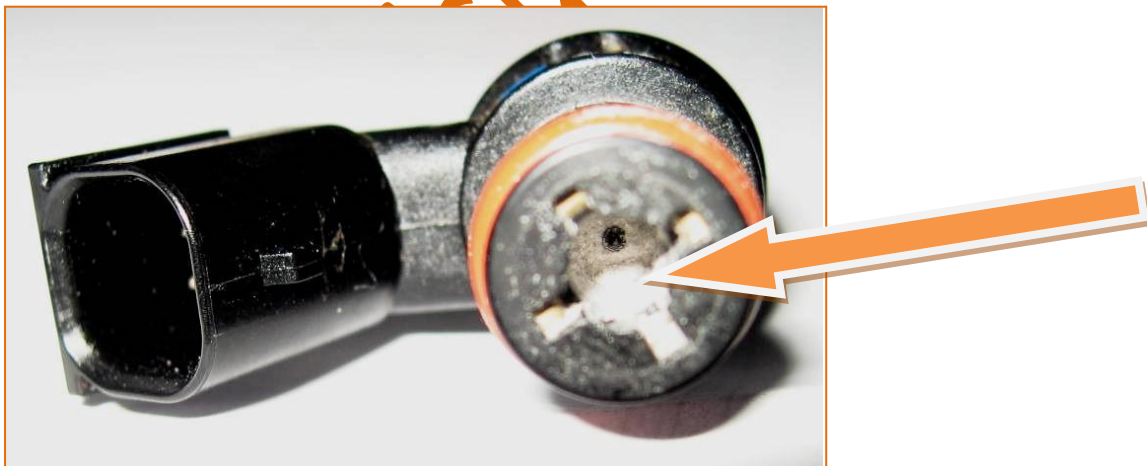
Defective injection valves are usually the result of dirt in the integrated filter (orange arrow). Dirt analysis have shown that a wide variety of substances are involved. Leisure Trail has a ultrasonic cleaner to remove this dirt.

To prevent dirt from entering the filter integrated in the injection valve, an **additional fuel screen (£5.04)** will be installed in the fuel line beginning with model year 2012.

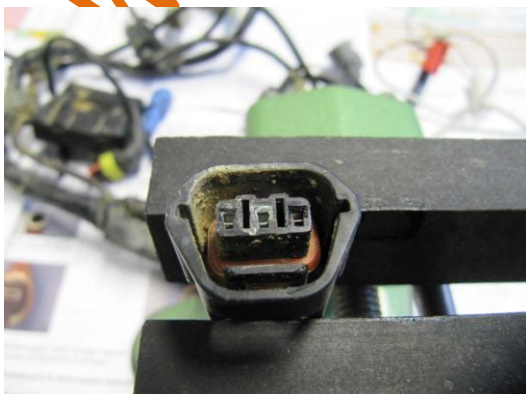
It is possible for dirt to contaminate electrical connector blocks, see below. You are advised to clean plugs with compressed air and not to treat plug-in connections in the EFI system with so called contact sprays (ie WD40).

These substances can lead to “creepage currents” which may lead to malfunctions due to the extremely low control voltages and currents.

Ensure that connectors are free of damage, dirt and corrosion. They should never be opened with screwdrivers or pliers.
